A19 NORTH ROAD, BROOKE'S GARAGE

Road Safety Review
Client: Mr Robin Wilson

17/03/2022

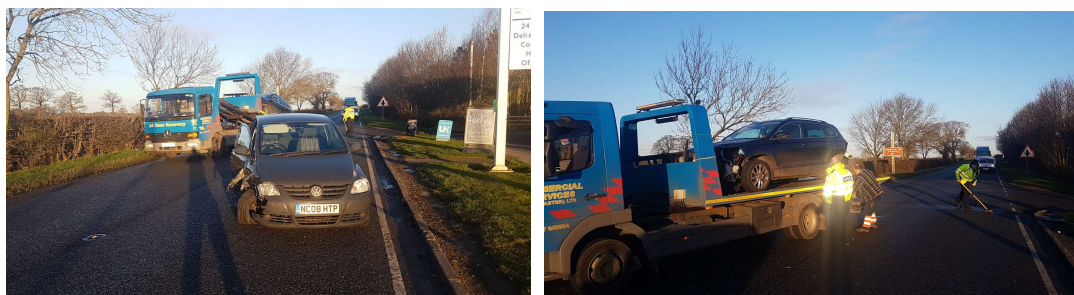
Figure 2.2 – Images from an incident on Wednesday 5 January 2022

- 2.1.5 In addition, the Road Safety Reviewer was provided with photographs of the aftermath of an incident that occurred on Wednesday 5 January 2022. It can be assumed that the incident either did not result in any personal injuries or the details have not reached the North Yorkshire County Council database. The images are shown in **Figure 2.2** overleaf.

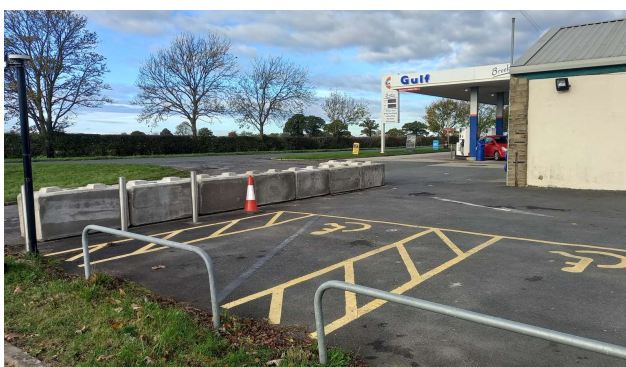
- Wilson Building – The perimeter of land under separate ownership at the access has been denoted by bollards and water-filled barriers.

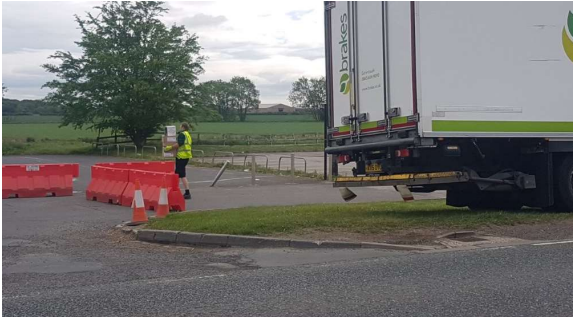
Unloading on A19

13	Collisions may occur if deliveries take place from A19. Incidents may include head-on and rear end collisions on the A19, and pedestrian collisions with garage layout.	3	4	12	<ul style="list-style-type: none"> Provide a delivery protocol which ensures no deliveries from the A19. Internal layout and queuing will also need to be addressed.

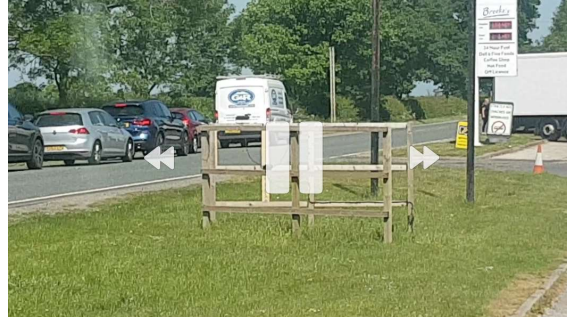
HGV reversing onto A19 (northern access)

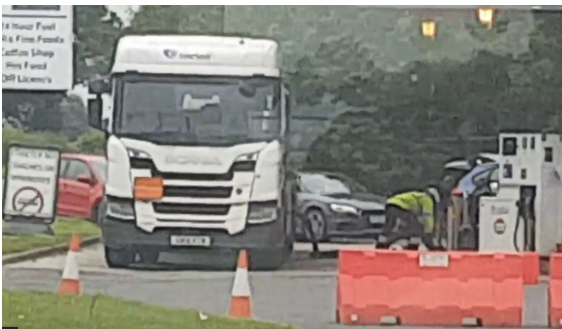
Fuel delivery

(Resulting in vehicles backing up onto A19)

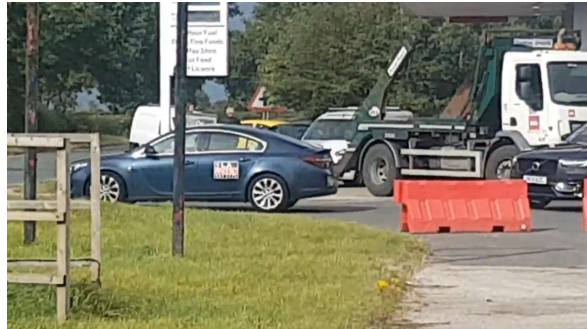
Vehicle congestion resulting in accesses being blocked

(Resulting in accesses blocked, and pedestrians moving around forecourt and queuing on A19)

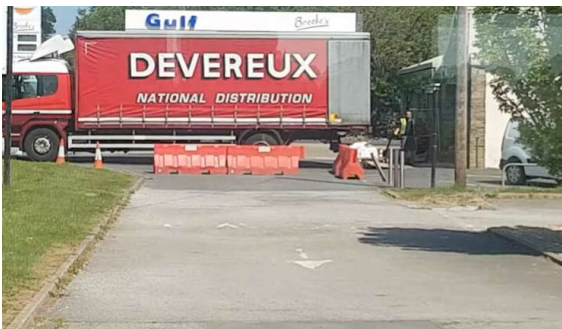
Access route blocked

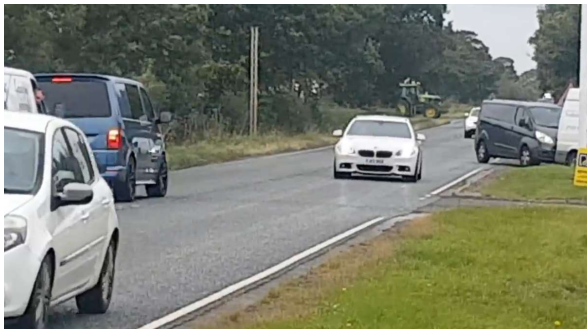
Queues backing onto A19 (resulting in vehicles also using adjacent access)

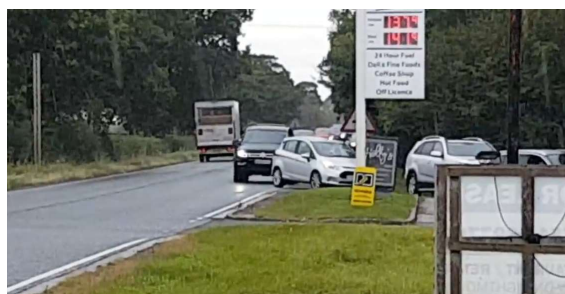
Queuing traffic on A19

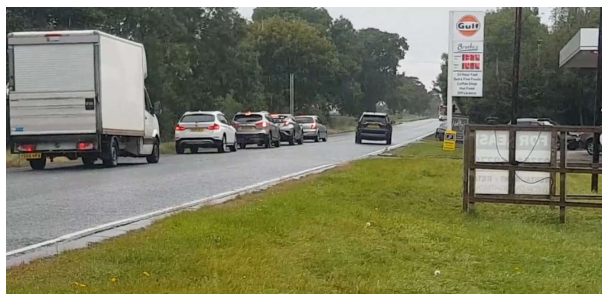
Queues forming behind right turning vehicle
(Driver frustration and hazardous manoeuvres)

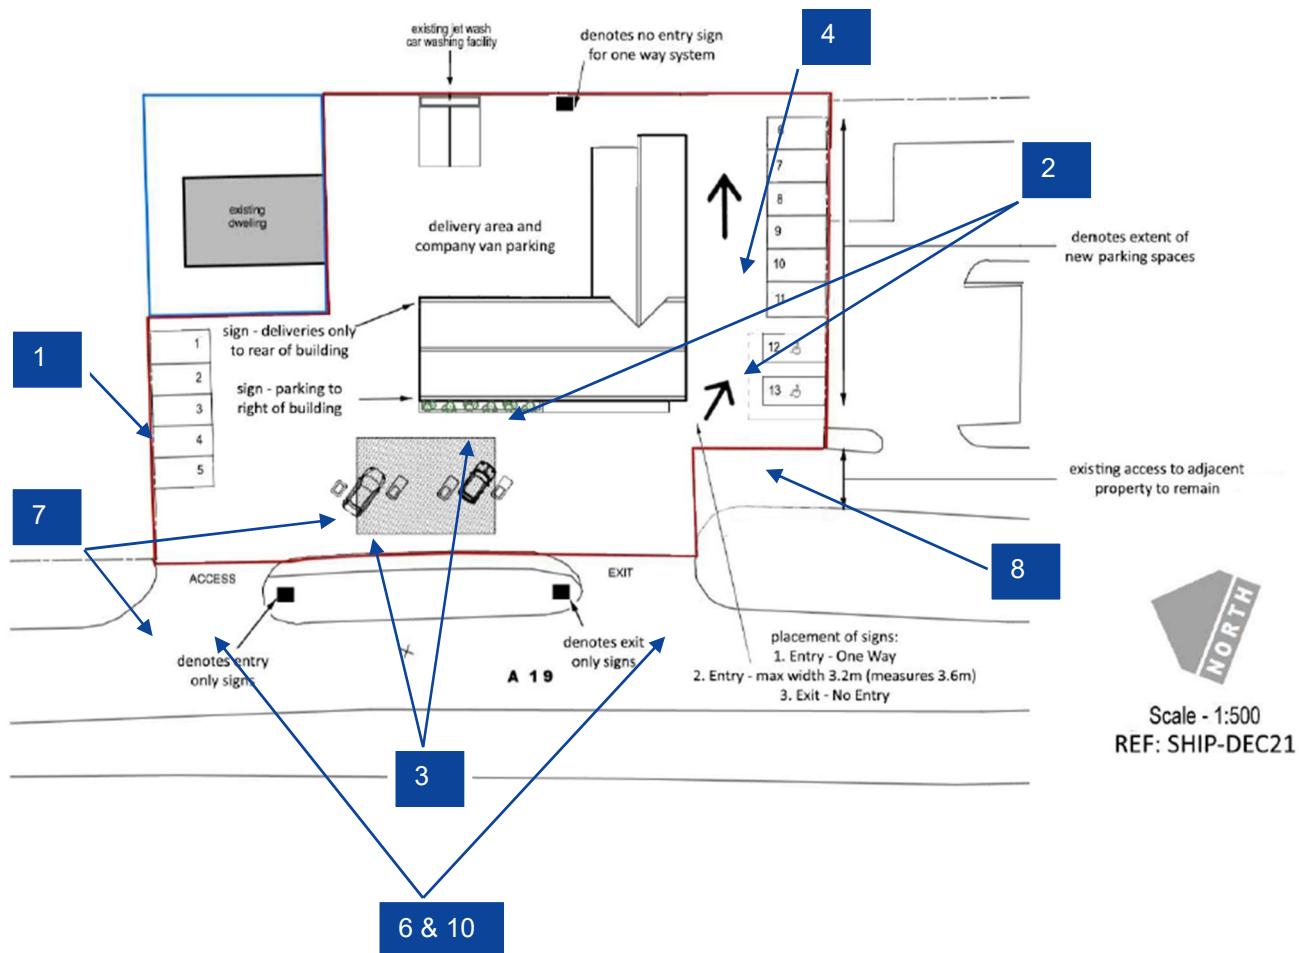
Appendix A: Location Plan

- 5. Fuel deliveries/servicing
- 9. Tracking of large vehicles
- 11. Parking throughout
- 12. Buildings impeding visibility
- 13. Deliveries from A19
