A19 NORTH ROAD, BROOKE'S GARAGE

Road Safety Review
Client: Mr Robin Wilson

17/03/2022

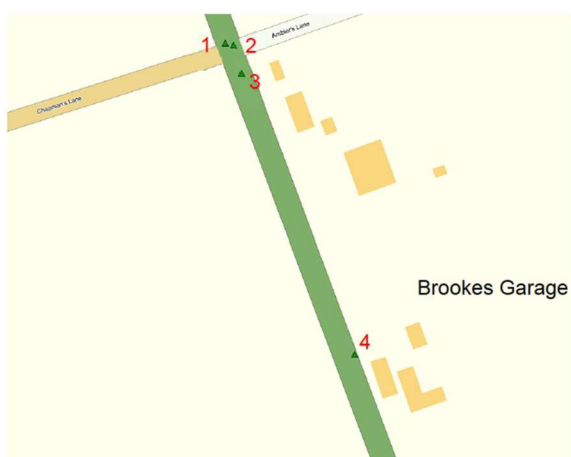
Figure 2.1 - Collision locations

- 2.1.2 It can be seen above in **Figure 2.1** that the collision search area extended beyond the study extents. Therefore, the collision data has been reviewed and collisions outside the study area have not been included in this analysis. It should also be noted that only collisions occurring on the A19 (public highway) can be registered and incidents within Brooke's Garage will not have been recorded.

- 2.1.3 During the study period, a total of one slight injury traffic collision has been recorded.
- 2.1.4 The collision occurred on 13 November 2017, at 08:40 in dry conditions. A van driven by a 68-year-old male, turned right from the garage to travel north. A northbound car, driven by a 42-year-old male, tries to overtake the van whilst it is turning and collides. The collision resulted in slight injuries to both drivers and a female passenger in the car.
